SEALED WITH A GLASS FIBER ROPE

By Christine L. Grahl

Reprinted from Ceramic Industry

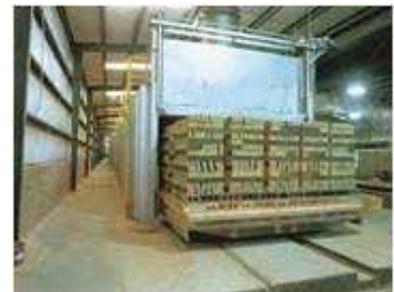
Turner knew he needed new seals, but he didn't know where to look. Then, in July of 1999, the solution arrived on his doorstep—literally. Turner opened a package to find a sample piece of 1 x 3 in. fiberglass rope, encased in stainless steel mesh.* At first glance, it looked like it was just what he needed. But Turner didn't want looks—he wanted results.

"We were really testing whether the seal would maintain some form of its size after compression between the kiln cars. A kiln car seal that is high in volume but lacks density flattens and remains flat as soon as the kiln cars are pushed together. Very few materials in our industry can withstand the kiln's heat and be light enough to maintain some sort of spring action, but maintaining a post-firing thickness is quite important," he said. According to Turner, the sample seals lost only about an eighth or a quarter of an inch during the first cycle of the trial, and then maintained their basic size and shape after that point. Turner was hooked. He placed
